The International Space Station and the Space Debris Environment: 10 years on

Nicholas Johnson¹, Heiner Klinkrad²

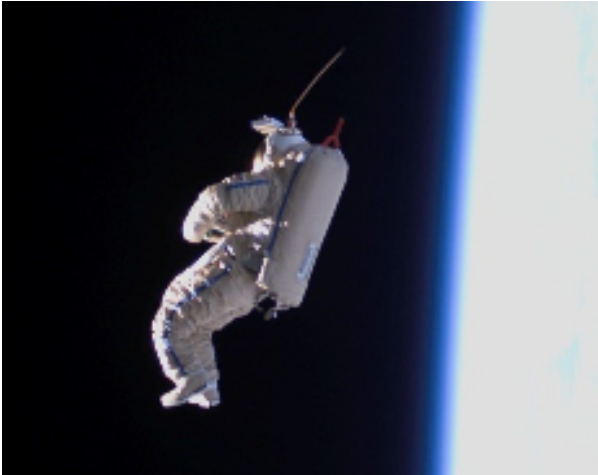
Figure 13. Discarded EVA suit released from ISS in February 2006.

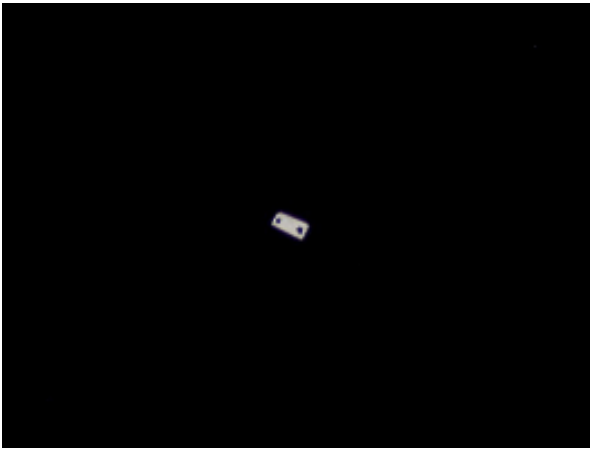
An unknown number of debris too small to be tracked and cataloged has also been generated. Very small secondary orbital debris are likely produced when the ISS is struck by high speed particles. Occasionally, the ISS crew has reported seeing and in some cases photographing objects several centimeters in size as they drift away from the station (Figure 14). Due to their low altitude and likely high area-to-mass ratios, these objects are believed to be even shorter-lived than their cataloged counterparts.

Figure 14. Small debris observed from ISS in June 2003.
